**Flood Control Project Maintenance
Levee Inspections**
LMA District Cover Sheet
Spring 2014 Levee Inspection Results

San Joaquin County Flood Control and Water Conservation District

Spring 2014 Levee Inspection Results

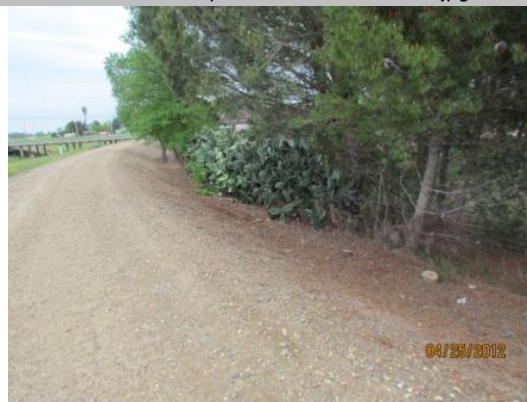
Photo 1 of 1 : pkazi_s_20140415_219.jpg

LM Start	13.54	Rating **	M	Issue No.	70
LM End	13.54	Issue Type +	En	Location *	LS
Category	Earthen Levee			GPS Latitude/Longitude	
				Start	End
Item	Vegetation			38.100925 °	38.100925 °
				-121.176894 °	-121.176894 °
DWR ID	DWR_NA0017_08_s_2012_70				
Action/Comments					
Landscaping Inspector Comments: Cacti was found on the landside of the levee.

Cacti was found on the landside of the levee looking upstream.

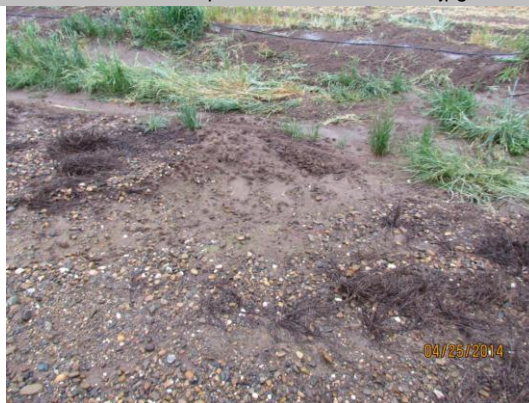
Photo 1 of 1 : pkazi_s_20140428_885.jpg

LM Start	13.61	Rating **	M	Issue No.	83
LM End	13.61	Issue Type +	Ma	Location *	LS
Category	Earthen Levee			GPS Latitude/Longitude	
				Start	End
Item	Slope Stability			38.101934 °	38.101934 °
				-121.177144 °	-121.177144 °
DWR ID	DWR_NA0017_08_s_2014_83				
Action/Comments					
Repair the levee slope damaged by vehicle traffic and prevent access where possible.

A slope instability was found on the landside of the levee looking upstream.

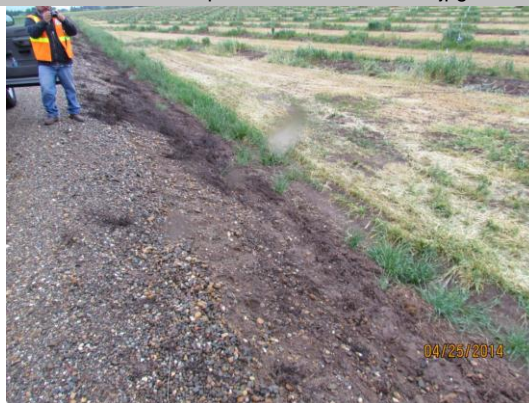
Photo 1 of 1 : pkazi_s_20140428_886.jpg

LM Start	13.68	Rating **	M	Issue No.	84
LM End	13.68	Issue Type +	Ma	Location *	LS
Category	Earthen Levee			GPS Latitude/Longitude	
				Start	End
Item	Encroachments			38.102876 °	38.102876 °
				-121.177057 °	-121.177057 °
DWR ID	DWR_NA0017_08_s_2014_84				
Action/Comments					
Agricultural tilling

Tilling along the landside toe was found at this location. The picture was taken from the crown looking upstream.

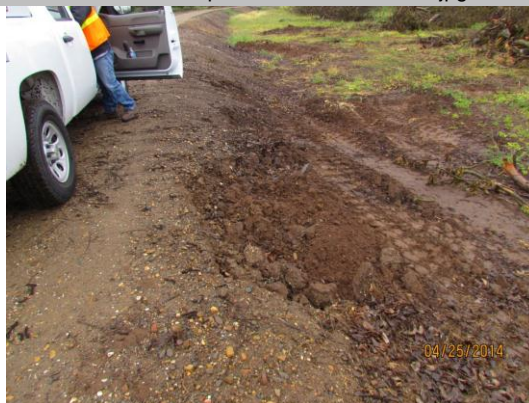
Photo 1 of 1 : pkazi_s_20140428_887.jpg

LM Start	15.18	Rating **	M	Issue No.	86
LM End	15.18	Issue Type +	Ma	Location *	LS
Category	Earthen Levee			GPS Latitude/Longitude	
				Start	End
Item	Slope Stability			38.122684 °	38.122684 °
				-121.169123 °	-121.169123 °
DWR ID	DWR_NA0017_08_s_2014_86				
Action/Comments					
Repair the levee slope damaged by vehicle traffic and prevent access where possible.

Slope instability was found on landside toe of the levee looking upstream.

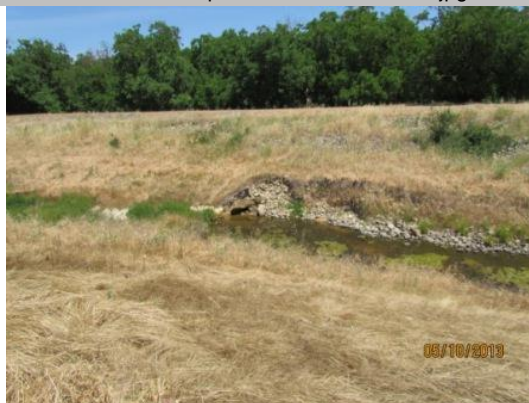
Photo 1 of 1 : pkazi_s_20140415_223.jpg

LM Start	15.20	Rating **	M	Issue No.	89
LM End	15.20	Issue Type +	Ma	Location *	WS
Category	Earthen Levee			GPS Latitude/Longitude	
				Start	End
Item	Erosion / Bank Caving			38.125818 °	38.125818 °
				-121.166410 °	-121.166410 °
DWR ID	DWR_NA0017_08_s_2013_89				
Action/Comments					
Schedule repair of erosion site prior to the next inspection.

Erosion was found on the waterside toe of the levee. The picture was taken from the opposite side of the levee.

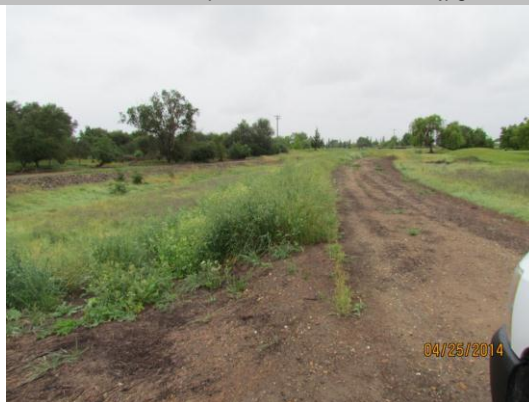
Photo 1 of 1 : pkazi_s_20140428_888.jpg

LM Start	15.24	Rating **	M	Issue No.	87
LM End	16.13	Issue Type +	Ma	Location *	WS
Category	Earthen Levee			GPS Latitude/Longitude	
				Start	End
Item	Vegetation			38.123586 °	38.129923 °
				-121.169204 °	-121.155906 °
DWR ID	DWR_NA0017_08_s_2014_87				
Action/Comments					
Control annual grass and weeds on the levee slopes and easements.

Vegetation on the waterside of the levee looking upstream.

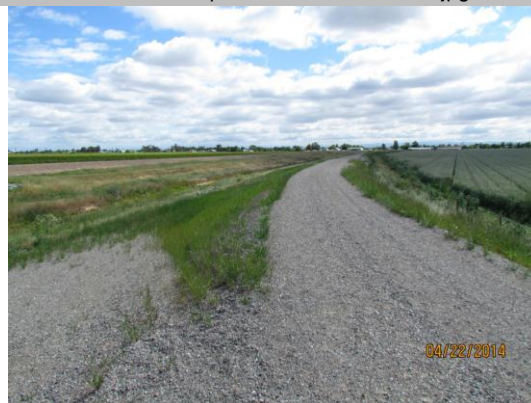
Photo 1 of 1 : pkazi_s_20140428_889.jpg

LM Start	0.09	Rating **	M	Issue No.	2
LM End	0.54	Issue Type +	Ma	Location *	WS
Category	Earthen Levee			GPS Latitude/Longitude	
				Start	End
Item	Vegetation			38.093939 °	38.094853 °
				-121.175063 °	-121.167116 °
DWR ID	DWR_NA0017_09_s_2014_2				
Action/Comments					
Control annual grass and weeds on the levee slopes and easements.

Vegetation on the waterside of the levee looking upstream.

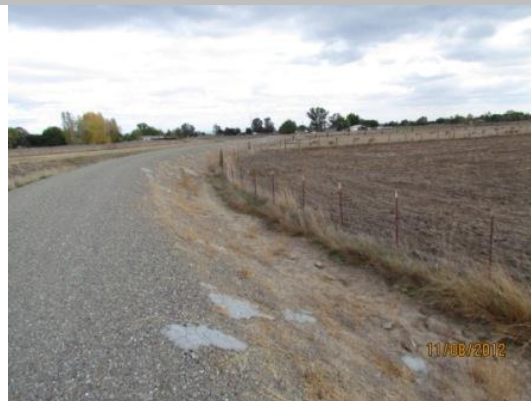
Photo 1 of 1 : pkazi_s_20140415_289.jpg

LM Start	0.09	Rating **	M	Issue No.	4
LM End	0.54	Issue Type +	En	Location *	WS
Category	Earthen Levee			GPS Latitude/Longitude	
				Start	End
Item	Encroachments			38.093939 °	38.094853 °
				-121.175063 °	-121.167116 °
DWR ID	DWR_NA0017_09_s_2014_4				
Action/Comments					
Fence

Fence was found on the landside toe of the levee looking upstream.

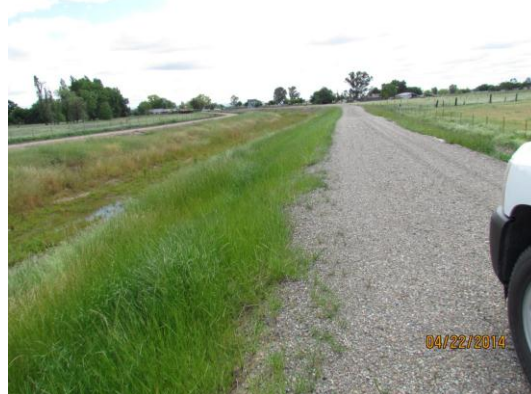
Photo 1 of 1 : pkazi_s_20140428_890.jpg

LM Start	1.24	Rating **	M	Issue No.	5
LM End	1.31	Issue Type +	Ma	Location *	WS
Category	Earthen Levee			GPS Latitude/Longitude	
				Start	End
Item	Vegetation			38.094405 °	38.094031 °
				-121.154737 °	-121.153362 °
DWR ID	DWR_NA0017_09_s _ 2014_5				
Action/Comments					
Control annual grass and weeds on the levee slopes and easements.

Vegetation on the waterside slope of the levee looking upstream.

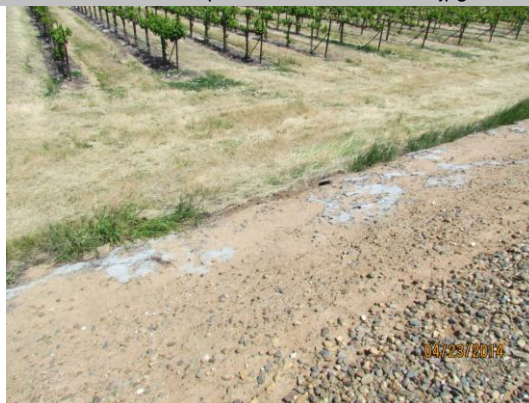
Photo 1 of 1 : pkazi_s_20140428_908.jpg

LM Start	0.27	Rating **	M	Issue No.	2
LM End	0.27	Issue Type +	Ma	Location *	LS
Category	Earthen Levee			GPS Latitude/Longitude	
				Start	End
Item	Encroachments			38.094919 °	38.094919 °
				-121.171145 °	-121.171145 °
DWR ID	DWR_NA0017_10_s_2014_2				
Action/Comments					
Agricultural tilling

Tilling was found on the landside toe of the levee looking upstream.

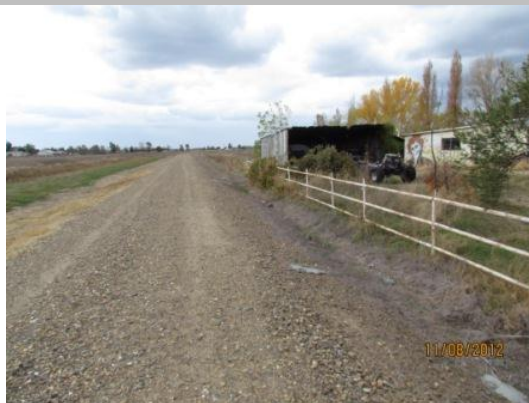
Photo 1 of 1 : pkazi_s_20140415_291.jpg

LM Start	0.35	Rating **	M	Issue No.	3
LM End	1.32	Issue Type +	En	Location *	LS
Category	Earthen Levee			GPS Latitude/Longitude	
				Start	End
Item	Encroachments			38.095021 °	38.094321 °
				-121.168428 °	-121.151156 °
DWR ID	DWR_NA0017_10_s_2012_3				
Action/Comments					
Fence

Fence was found on the landside toe of the levee looking downstream.

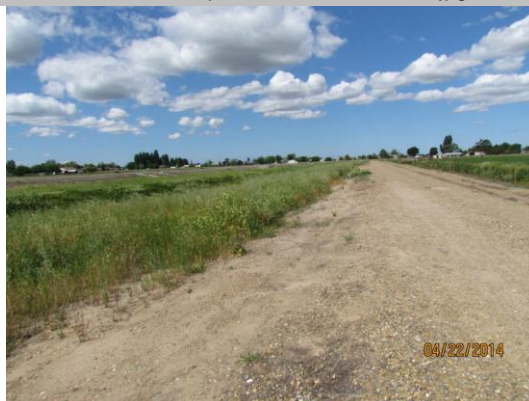
Photo 1 of 1 : pkazi_s_20140428_892.jpg

LM Start	0.38	Rating **	M	Issue No.	4
LM End	0.87	Issue Type +	Ma	Location *	WS
Category	Earthen Levee			GPS Latitude/Longitude	
				Start	End
Item	Vegetation			38.095079 °	38.094636 °
				-121.167879 °	-121.159228 °
DWR ID	DWR_NA0017_10_s_2014_4				
Action/Comments					
Control annual grass and weeds on the levee slopes and easements.

View of the vegetation on the waterside slope of the levee looking downstream.

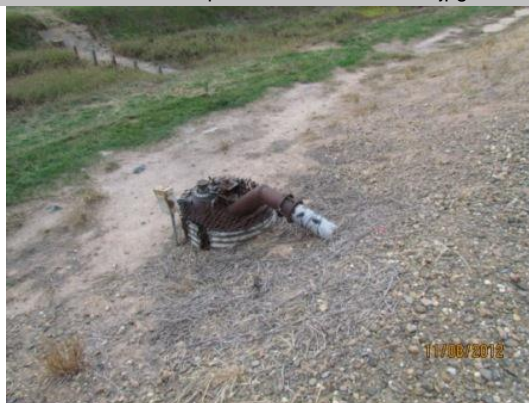
Photo 1 of 1 : pkazi_s_20140415_296.jpg

LM Start	0.42	Rating **	M	Issue No.	8
LM End	0.42	Issue Type +	En	Location *	WS
Category	Earthen Levee			GPS Latitude/Longitude	
				Start	End
Item	Encroachments			38.095145 °	38.095145 °
				-121.167269 °	-121.167269 °
DWR ID	DWR_NA0017_10_s_2012_8				
Action/Comments					
Pipe					
Inspector Comments: Pipe penetrating under the levee crown.

Pipe penetration was found under the crown of the levee looking downstream.

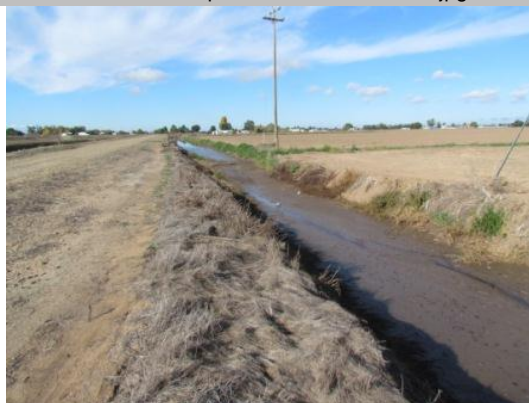
Photo 1 of 2 : pkazi_s_20140415_294.jpg

LM Start	0.71	Rating **	M	Issue No.	7
LM End	0.97	Issue Type +	En	Location *	LS
Category	Earthen Levee			GPS Latitude/Longitude	
				Start	End
Item	Encroachments			38.094606 °	38.094708 °
				-121.162138 °	-121.157569 °
DWR ID	DWR_NA0017_10_s_2012_7				
Action/Comments					
Ditch

An agricultural ditch was found on the landside of the levee looking downstream.

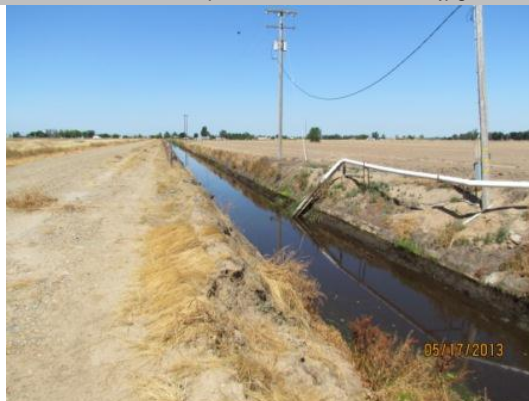
Photo 2 of 2 : pkazi_s_20140415_295.jpg

LM Start	0.71	Rating **	M	Issue No.	7 (cont)
LM End	0.97	Issue Type +	En	Location *	LS

Updated picture of the agricultural ditch on the landside of the levee looking downstream.

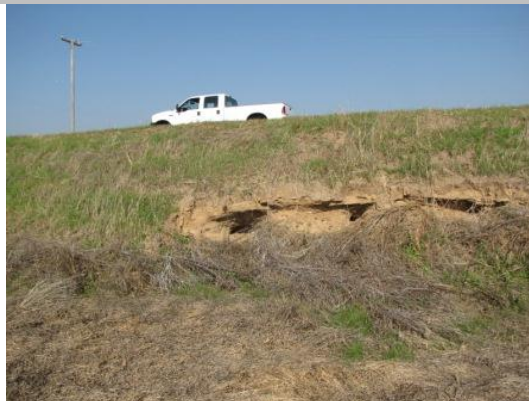
Photo 1 of 2 : pkazi_s_20140415_292.jpg

LM Start	0.87	Rating **	M	Issue No.	5
LM End	0.87	Issue Type +	Ma	Location *	WS
Category	Earthen Levee			GPS Latitude/Longitude	
				Start	End
Item	Animal Control			38.094671 °	38.094671 °
				-121.159286 °	-121.159286 °
DWR ID	DWR_NA0017_10_s_2012_5				
Action/Comments					
No rodents visible, but rodent burrows visible; need to backfill and

View of rodent holes in the waterward berm from the channel.

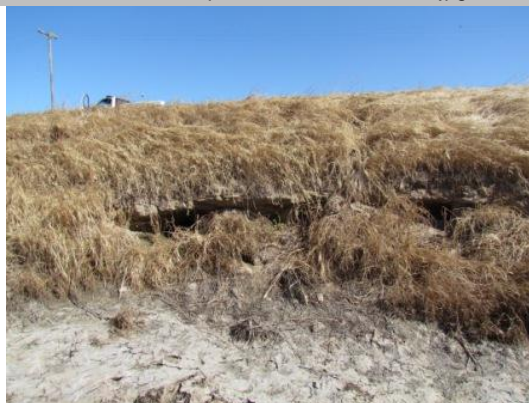
Photo 2 of 2 : pkazi_s_20140415_293.jpg

LM Start	0.87	Rating **	M	Issue No.	5 (cont)
LM End	0.87	Issue Type +	Ma	Location *	WS

Erosion above the pilot channel was located but it didn't look like rodent holes. The picture was taken from the toe at the waterside of the levee looking towards the crown.

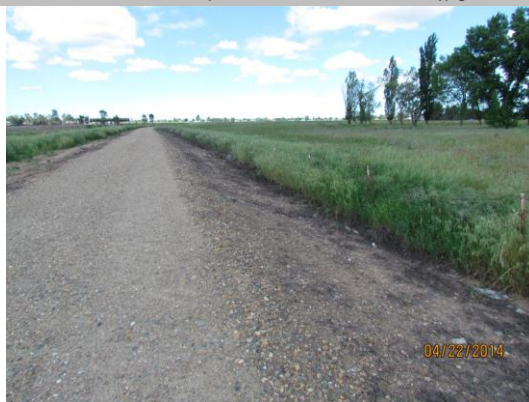
Photo 1 of 1 : pkazi_s_20140428_891.jpg

LM Start	1.12	Rating **	M	Issue No.	1
LM End	1.29	Issue Type +	En	Location *	LS
Category	Earthen Levee			GPS Latitude/Longitude	
				Start	End
Item	Encroachments			38.094670 °	38.094322 °
				-121.154616 °	-121.151764 °
DWR ID	DWR_NA0017_10_s_2014_1				
Action/Comments					
Fence

A fence was found on the landside toe of the levee looking downstream.

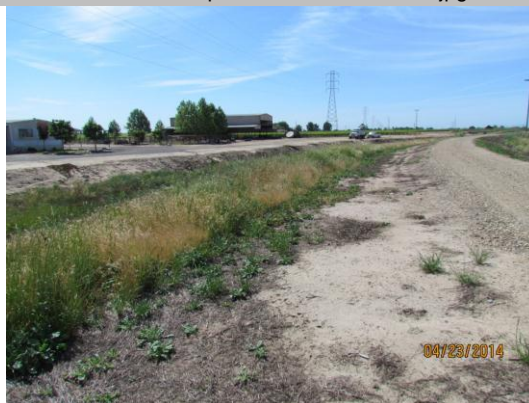
Photo 1 of 1 : pkazi_s_20140428_907.jpg

LM Start	0.00	Rating **	M	Issue No.	6
LM End	3.55	Issue Type +	Ma	Location *	WS
Category	Earthen Levee			GPS Latitude/Longitude	
				Start	End
Item	Vegetation			38.095074 °	38.131648 °
				-121.169890 °	-121.138832 °
DWR ID	DWR_NA0017_11_s_2014_6				
Action/Comments					
Control annual grass and weeds on the levee slopes and easements.

View of the vegetation on the waterside of the levee looking downstream.

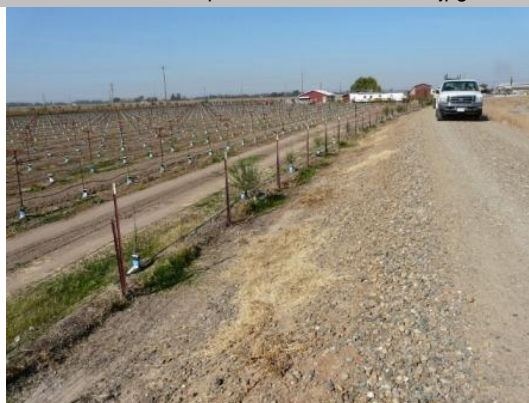
Photo 1 of 1 : pkazi_s_20140415_298.jpg

LM Start	0.17	Rating **	M	Issue No.	2
LM End	0.49	Issue Type +	En	Location *	LS
Category	Earthen Levee			GPS Latitude/Longitude	
				Start	End
Item	Encroachments			38.097243 °	38.101853 °
				-121.169258 °	-121.168563 °
DWR ID	DWR_NA0017_11_s_2012_2				
Action/Comments					
Fence

Fence located from LM 0.17 to LM 0.49 and crops located from LM 0.17 to LM 0.41 within 10' from landside toe of levee.

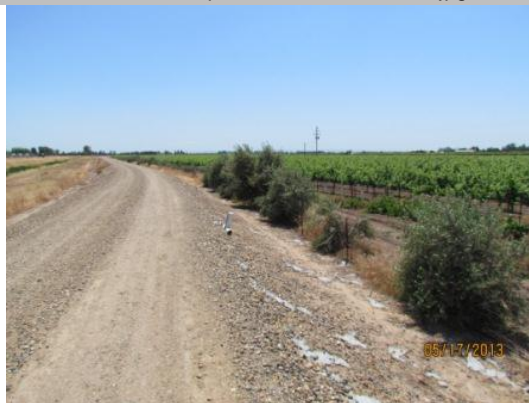
Photo 1 of 1 : pkazi_s_20140415_299.jpg

LM Start	0.17	Rating **	M	Issue No.	3
LM End	0.41	Issue Type +	En	Location *	LS
Category	Earthen Levee			GPS Latitude/Longitude	
				Start	End
Item	Encroachments			38.097342 °	38.100685 °
				-121.169262 °	-121.169112 °
DWR ID	DWR_NA0017_11_s_2012_3				
Action/Comments					
Crops					
Inspector Comments: Newly planted trees within 10' from landside toe

Crops were found on the landside toe of the levee looking downstream.

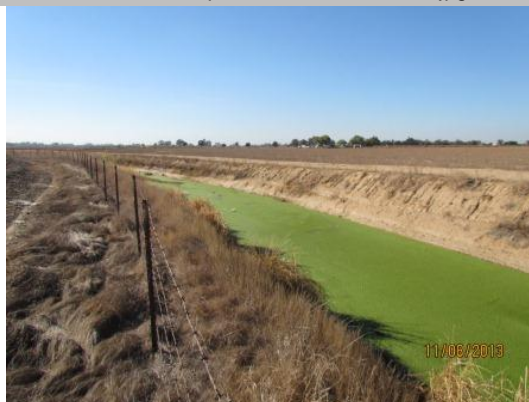
Photo 1 of 5 : pkazi_s_20140415_309.jpg

LM Start	1.07	Rating **	U	Issue No.	206
LM End	1.14	Issue Type +	En	Location *	LS
Category	Earthen Levee			GPS Latitude/Longitude	
				Start	End
Item	Encroachments			38.109070 °	38.109595 °
				-121.165992 °	-121.164954 °
DWR ID	DWR_NA0017_11_s_2012_206				
Action/Comments					
Ditch					
Inspector Comments: A notice of violation was issued to the owner for this ditch during fall 2011 inspection.

Updated picture of the ditch on the landside of the levee during fall 2013 inspection looking downstream.

REQUESTED CORRECTION: Repair the ditch at the landside toe of the levee. The ditch is approximately 10 feet in width from the toe of the levee. likely to cause significant levee stability issue.

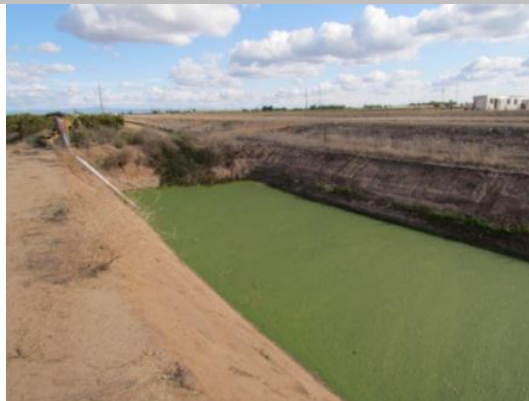
Photo 2 of 5 : pkazi_s_20140415_305.jpg

LM Start	1.07	Rating **	U	Issue No.	206 (cont)
LM End	1.14	Issue Type +	En	Location *	LS

View of the ditch on the landside of the levee looking upstream. The picture was taken during fall 2011 inspection.

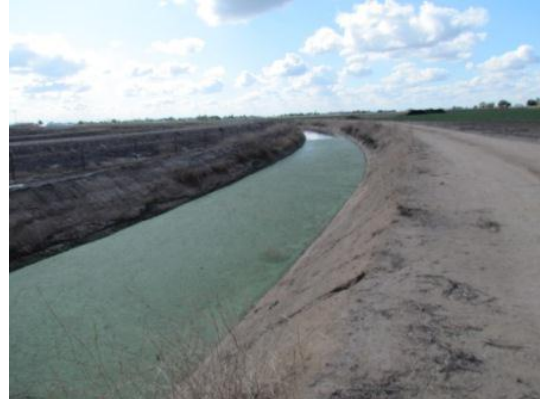
Photo 3 of 5 : pkazi_s_20140415_306.jpg

LM Start	1.07	Rating **	U	Issue No.	206 (cont)
LM End	1.14	Issue Type +	En	Location *	LS
Category	Earthen Levee			GPS Latitude/Longitude	
				Start	End
Item	Encroachments			38.109070 °	38.109595 °
				-121.165992 °	-121.164954 °
DWR ID	DWR_NA0017_11_s_2012_206				
Action/Comments					
Ditch

View of the ditch on the landside of the levee looking downstream. The picture was taken during fall 2011 inspection.

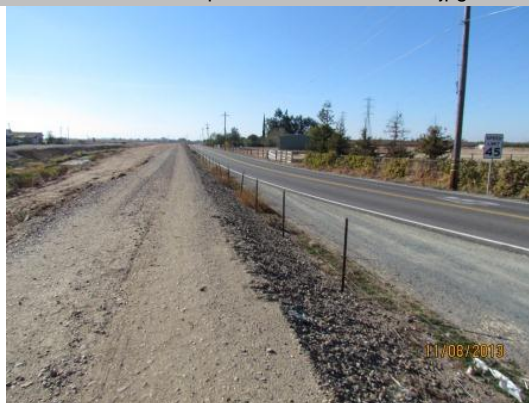
Photo 1 of 1 : pkazi_s_20140415_302.jpg

LM Start	2.03	Rating **	M	Issue No.	7
LM End	2.23	Issue Type +	En	Location *	LS
Category	Earthen Levee			GPS Latitude/Longitude	
				Start	End
Item	Encroachments			38.116984 °	38.118019 °
				-121.154293 °	-121.150827 °
DWR ID	DWR_NA0017_11_s_2012_7				
Action/Comments					
Fence

A fence was found on the landside slope of the levee looking downstream.

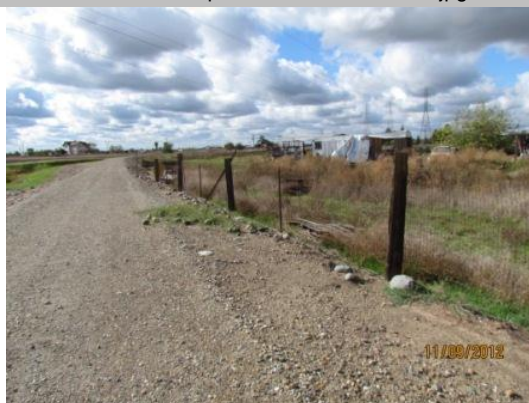
Photo 1 of 1 : pkazi_s_20140415_301.jpg

LM Start	2.25	Rating **	M	Issue No.	5
LM End	2.42	Issue Type +	En	Location *	LS
Category	Earthen Levee			GPS Latitude/Longitude	
				Start	End
Item	Encroachments			38.118090 °	38.119080 °
				-121.150612 °	-121.148152 °
DWR ID	DWR_NA0017_11_s_2012_5				
Action/Comments					
Fence					
Inspector Comments: Barbed wire fence within 10' of the landward toe.

A fence was found on the landside toe of the levee looking downstream.

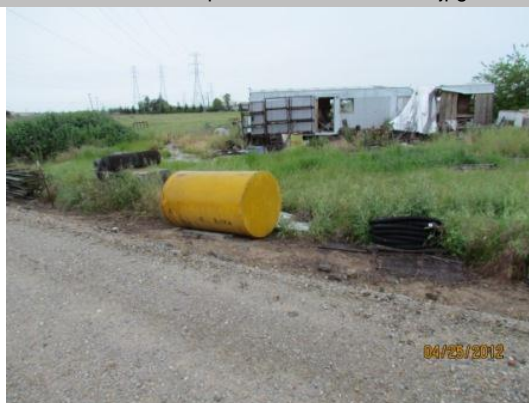
Photo 1 of 1 : pkazi_s_20140415_303.jpg

LM Start	2.40	Rating **	M	Issue No.	8
LM End	2.40	Issue Type +	En	Location *	LS
Category	Earthen Levee			GPS Latitude/Longitude	
				Start	End
Item	Encroachments			38.118902 °	38.118902 °
				-121.148408 °	-121.148408 °
DWR ID	DWR_NA0017_11_s_2012_8				
Action/Comments					
Tank

A tank and debris was found on the landside of the levee looking downstream.

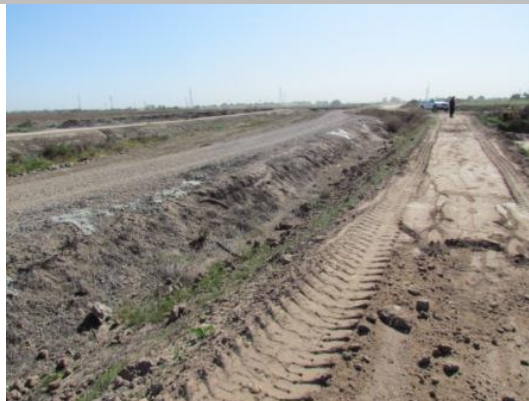
Photo 1 of 1 : pkazi_s_20140415_300.jpg

LM Start	2.90	Rating **	M	Issue No.	4
LM End	3.14	Issue Type +	En	Location *	LS
Category	Earthen Levee			GPS Latitude/Longitude	
				Start	End
Item	Encroachments			38.124677 °	38.127095 °
				-121.144272 °	-121.142371 °
DWR ID	DWR_NA0017_11_s_2012_4				
Action/Comments					
Ditch

A ditch was found on the landside of the levee looking downstream.

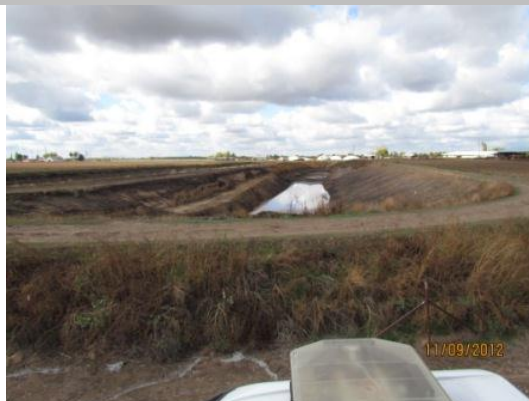
Photo 1 of 1 : pkazi_s_20140415_304.jpg

LM Start	2.97	Rating **	M	Issue No.	16
LM End	2.97	Issue Type +	En	Location *	LS
Category	Earthen Levee			GPS Latitude/Longitude	
				Start	End
Item	Encroachments			38.125636 °	38.125636 °
				-121.144298 °	-121.144298 °
DWR ID	DWR_NA0017_11_f_2012_16				
Action/Comments					
Ditch Inspector Comments: A detention pond was dug by the farmer next to the toe of the levee. It appears that it may interfere with the levee prism.

A detention pond was found next the landside toe of the levee. The pond had approximately depth of 15 feet. The picture was taken from the crown looking towards the toe of the levee.

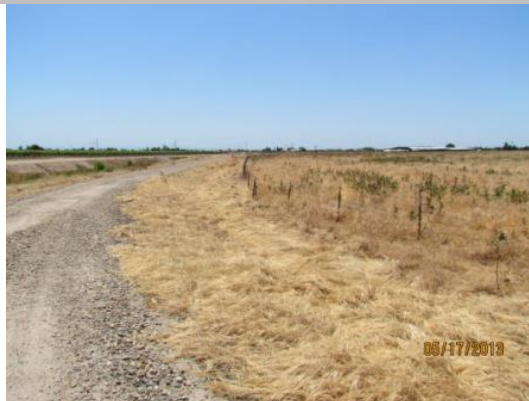
Photo 1 of 1 : pkazi_s_20140415_297.jpg

LM Start	3.05	Rating **	M	Issue No.	1
LM End	3.54	Issue Type +	En	Location *	LS
Category	Earthen Levee			GPS Latitude/Longitude	
				Start	End
Item	Encroachments			38.126664 °	38.131522 °
				-121.144080 °	-121.138843 °
DWR ID	DWR_NA0017_11_s _ 2012_1				
Action/Comments					
Fence

A fence was found on the landside slope of the levee looking downstream.

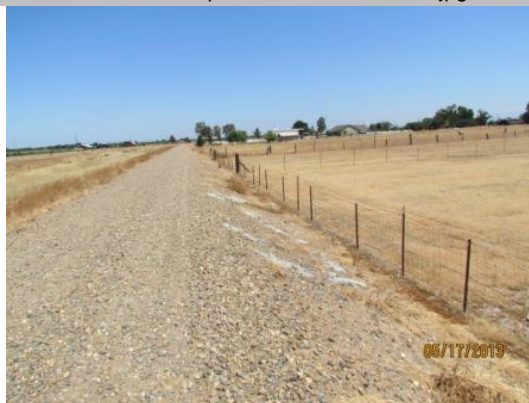
Photo 1 of 1 : pkazi_s_20140415_310.jpg

LM Start	0.01	Rating **	M	Issue No.	1
LM End	0.66	Issue Type +	En	Location *	LS
Category	Earthen Levee			GPS Latitude/Longitude	
				Start	End
Item	Encroachments			38.095226 °	38.103637 °
				-121.168822 °	-121.165796 °
DWR ID	DWR_NA0017_12_s_2012_1				
Action/Comments					
Fence

Fence was found on the landside toe of the levee looking upstream.

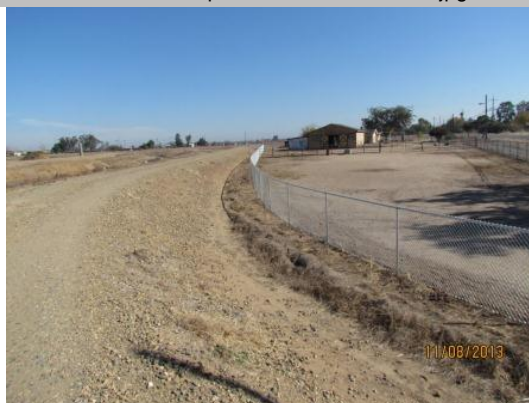
Photo 1 of 1 : pkazi_s_20140415_312.jpg

LM Start	0.48	Rating **	M	Issue No.	4
LM End	0.59	Issue Type +	En	Location *	LS
Category	Earthen Levee			GPS Latitude/Longitude	
				Start	End
Item	Encroachments			38.101926 °	38.102616 °
				-121.167822 °	-121.166169 °
DWR ID	DWR_NA0017_12_f_2013_4				
Action/Comments					
Fence

Fence was found on the landside toe of the levee looking upstream.

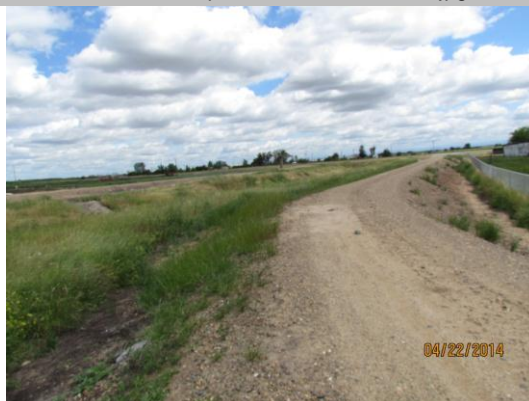
Photo 1 of 1 : pkazi_s_20140428_893.jpg

LM Start	0.49	Rating **	M	Issue No.	5
LM End	0.61	Issue Type +	Ma	Location *	WS
Category	Earthen Levee			GPS Latitude/Longitude	
				Start	End
Item	Vegetation			38.101955 °	38.103031 °
				-121.167805 °	-121.165839 °
DWR ID	DWR_NA0017_12_s_2014_5				
Action/Comments					
Control annual grass and weeds on the levee slopes and easements.

View of the vegetation on the waterside of the levee looking upstream.

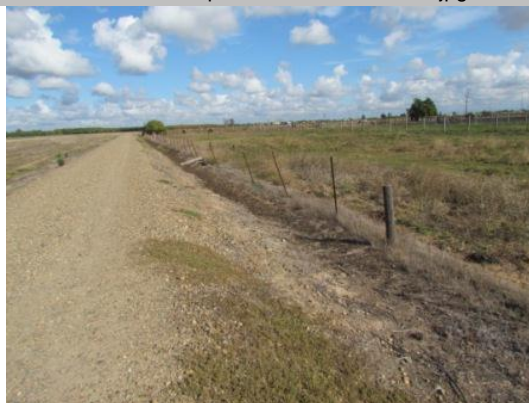
Photo 1 of 1 : pkazi_s_20140415_311.jpg

LM Start	0.59	Rating **	M	Issue No.	3
LM End	1.30	Issue Type +	En	Location *	LS
Category	Earthen Levee			GPS Latitude/Longitude	
				Start	End
Item	Encroachments			38.102617 °	38.109301 °
				-121.166169 °	-121.160586 °
DWR ID	DWR_NA0017_12_s_2012_3				
Action/Comments					
Fence

A fence was located on the landside toe of the levee looking upstream.

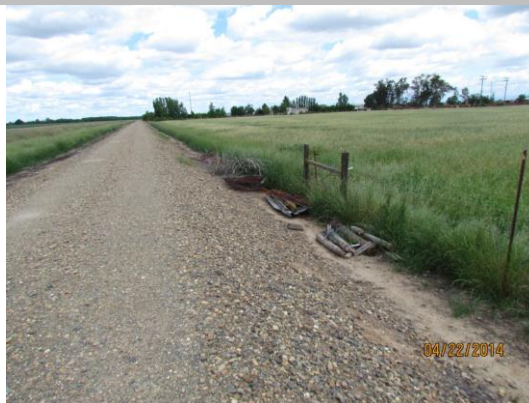
Photo 1 of 1 : pkazi_s_20140428_894.jpg

LM Start	0.65	Rating **	M	Issue No.	7
LM End	0.65	Issue Type +	Ma	Location *	LS
Category	Earthen Levee			GPS Latitude/Longitude	
				Start	End
Item	Encroachments			38.103371 °	38.103371 °
				-121.165763 °	-121.165763 °
DWR ID	DWR_NA0017_12_s_2014_7				
Action/Comments					
Debris

Debris was found on the landside toe of the levee looking upstream.

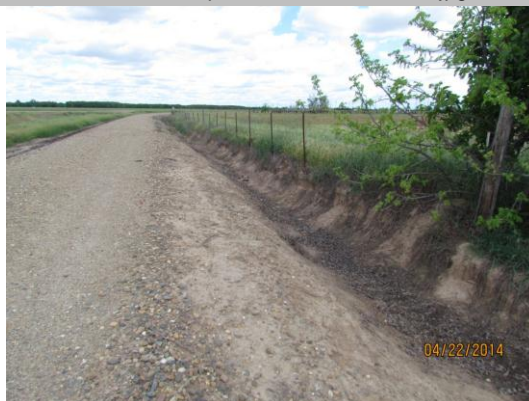
Photo 1 of 1 : pkazi_s_20140428_895.jpg

LM Start	0.93	Rating **	M	Issue No.	6
LM End	1.03	Issue Type +	En	Location *	LS
Category	Earthen Levee			GPS Latitude/Longitude	
				Start	End
Item	Encroachments			38.107523 °	38.108964 °
				-121.165785 °	-121.165448 °
DWR ID	DWR_NA0017_12_s_2012_6				
Action/Comments					
Ditch

A ditch was found on the landside toe of the levee looking upstream.

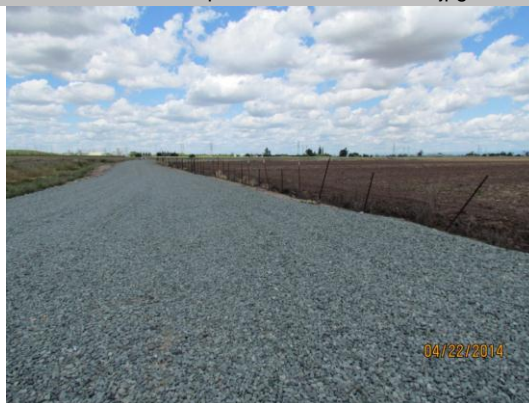
Photo 1 of 1 : pkazi_s_20140428_896.jpg

LM Start	1.38	Rating **	M	Issue No.	2
LM End	1.51	Issue Type +	En	Location *	LS
Category	Earthen Levee			GPS Latitude/Longitude	
				Start	End
Item	Encroachments			38.110609 °	38.111920 °
				-121.160047 °	-121.158684 °
DWR ID	DWR_NA0017_12_s_2012_2				
Action/Comments					
Fence

View of the fence on the landside of the levee looking upstream.

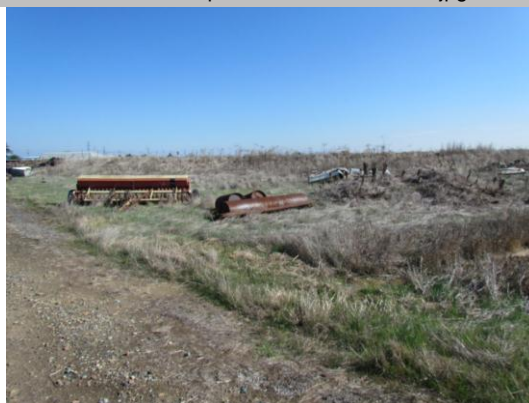
Photo 1 of 1 : pkazi_s_20140415_322.jpg

LM Start	1.81	Rating **	M	Issue No.	108
LM End	1.81	Issue Type +	En	Location *	LS
Category	Earthen Levee			GPS Latitude/Longitude	
				Start	End
Item	Encroachments			38.114636 °	38.114636 °
				-121.155564 °	-121.155564 °
DWR ID	DWR_NA0017_12_s_2012_108				
Action/Comments					
Equipment

Equipment was found on the landside of the levee looking upstream.

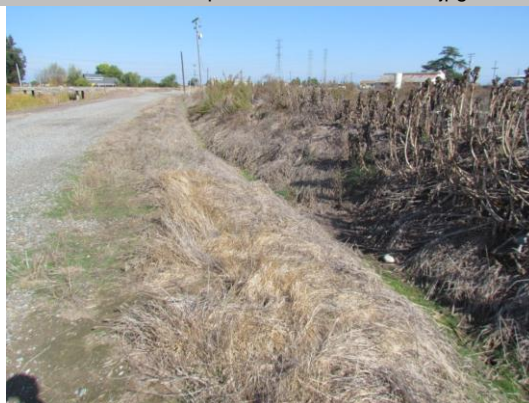
Photo 1 of 1 : pkazi_s_20140415_323.jpg

LM Start	1.91	Rating **	M	Issue No.	109
LM End	1.91	Issue Type +	En	Location *	LS
Category	Earthen Levee			GPS Latitude/Longitude	
				Start	End
Item	Encroachments			38.115993 °	38.115993 °
				-121.154539 °	-121.154539 °
DWR ID	DWR_NA0017_12_s_2012_109				
Action/Comments					
Ditch

A ditch was located on the landside toe of the levee looking upstream.

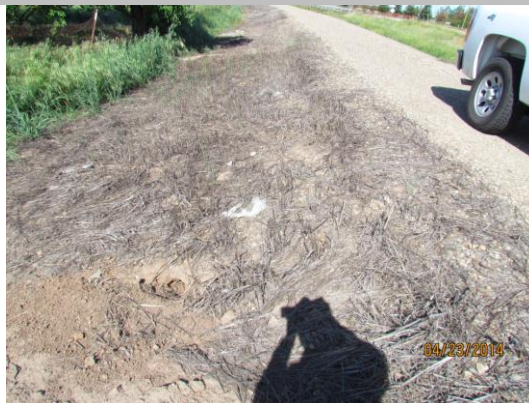
Photo 1 of 1 : pkazi_s_20140428_901.jpg

LM Start	2.22	Rating **	M	Issue No.	9
LM End	2.22	Issue Type +	Ma	Location *	LS
Category	Earthen Levee			GPS Latitude/Longitude	
				Start	End
Item	Animal Control			38.117784 °	38.117784 °
				-121.149763 °	-121.149763 °
DWR ID	DWR_NA0017_12_s_2014_9				
Action/Comments					
No rodents visible, but rodent burrows visible; need to backfill and compact or grout burrows.

A rodent hole was found on the landside of the levee looking downstream.

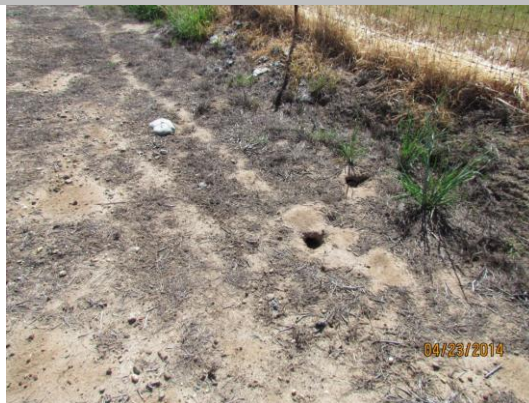
Photo 1 of 1 : pkazi_s_20140428_902.jpg

LM Start	2.25	Rating **	M	Issue No.	11
LM End	2.25	Issue Type +	Ma	Location *	LS
Category	Earthen Levee			GPS Latitude/Longitude	
				Start	End
Item	Animal Control			38.117807 °	38.117807 °
				-121.149233 °	-121.149233 °
DWR ID	DWR_NA0017_12_s_2014_11				
Action/Comments					
No rodents visible, but rodent burrows visible; need to backfill and compact or grout burrows.

Rodent holes were found on the landside toe of the levee upstream.

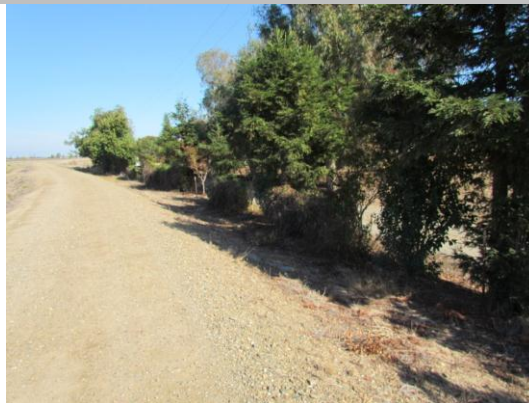
Photo 1 of 1 : pkazi_s_20140415_313.jpg

LM Start	2.37	Rating **	M	Issue No.	8
LM End	2.43	Issue Type +	En	Location *	LS
Category	Earthen Levee			GPS Latitude/Longitude	
				Start	End
Item	Vegetation			38.118957 °	38.119761 °
				-121.147865 °	-121.147461 °
DWR ID	DWR_NA0017_12_s_2012_8				
Action/Comments					
Landscaping

Trees and landscaping was found on the landside of the levee looking upstream.

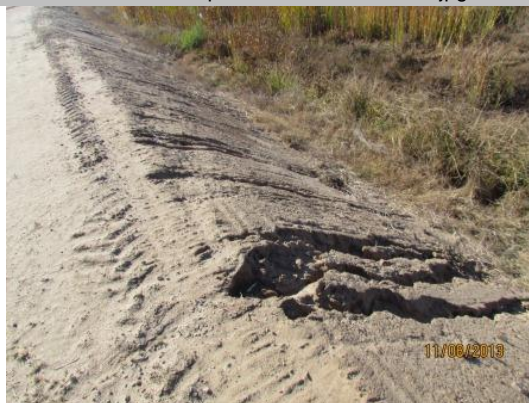
Photo 1 of 3 : pkazi_s_20140415_319.jpg

LM Start	3.28	Rating **	M	Issue No.	23
LM End	3.28	Issue Type +	Ma	Location *	WS
Category	Earthen Levee			GPS Latitude/Longitude	
				Start	End
Item	Erosion / Bank Caving			38.128445 °	38.128445 °
				-121.139594 °	-121.139594 °
DWR ID	DWR_NA0017_12_f_2012_23				
Action/Comments					
Schedule repair of erosion site prior to the next inspection.

Updated picture of the slope instability on the waterside of the levee. The picture was taken during fall 2013 inspection looking downstream.

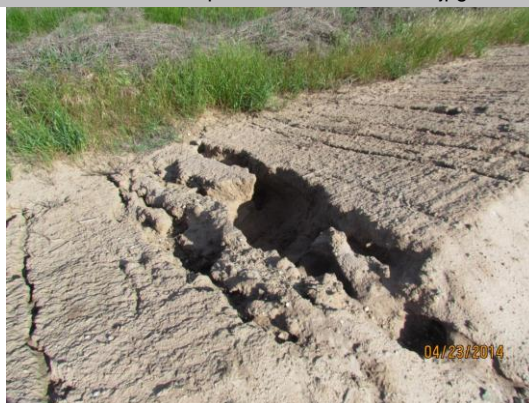
Photo 2 of 3 : pkazi_s_20140428_904.jpg

LM Start	3.28	Rating **	M	Issue No.	23 (cont)
LM End	3.28	Issue Type +	Ma	Location *	WS

Updated picture of the slope instability on the waterside of the levee. The picture was taken during the spring 2014 inspection looking upstream.

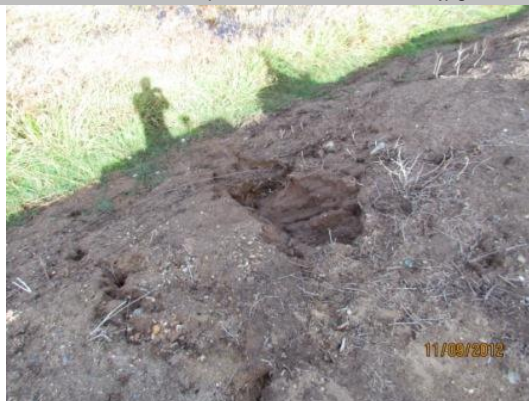
Photo 3 of 3 : pkazi_s_20140415_318.jpg

LM Start	3.28	Rating **	M	Issue No.	23 (cont)
LM End	3.28	Issue Type +	Ma	Location *	WS

Slope instability was found on the waterside slope of the levee looking upstream.

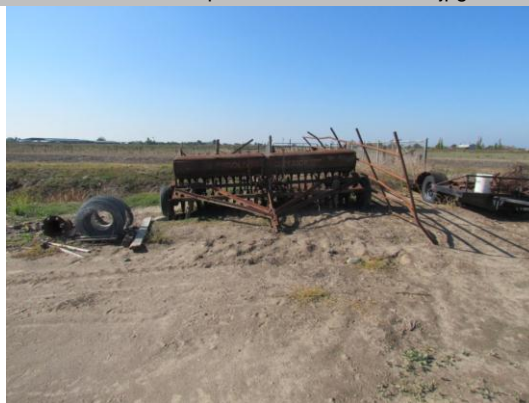
Photo 1 of 1 : pkazi_s_20140415_324.jpg

LM Start	3.39	Rating **	M	Issue No.	113
LM End	3.39	Issue Type +	Ma	Location *	WS
Category	Earthen Levee			GPS Latitude/Longitude	
				Start	End
Item	Encroachments			38.130018 °	38.130018 °
				-121.139019 °	-121.139019 °
DWR ID	DWR_NA0017_12_s_2012_113				
Action/Comments					
Equipment

Farming equipment was found on the waterside of the levee looking upstream.

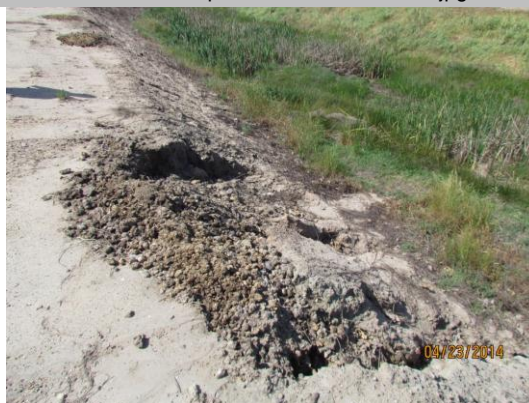
Photo 1 of 3 : pkazi_s_20140428_905.jpg

LM Start	3.48	Rating **	M	Issue No.	24
LM End	3.48	Issue Type +	Ma	Location *	WS
Category	Earthen Levee			GPS Latitude/Longitude	
				Start	End
Item	Erosion / Bank Caving			38.131140 °	38.131140 °
				-121.138541 °	-121.138541 °
DWR ID	DWR_NA0017_12_f_2012_24				
Action/Comments					
Schedule repair of erosion site prior to the next inspection.

Updated picture of the erosion on the waterside of the levee. The picture was taken during spring 2014 inspection looking downstream.

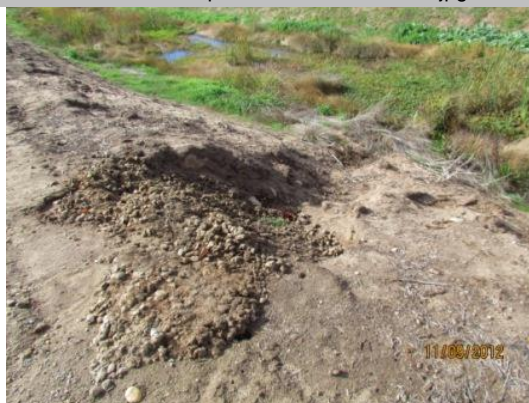
Photo 2 of 3 : pkazi_s_20140415_320.jpg

LM Start	3.48	Rating **	M	Issue No.	24 (cont)
LM End	3.48	Issue Type +	Ma	Location *	WS

Erosion was found on the waterside slope of the levee looking downstream.

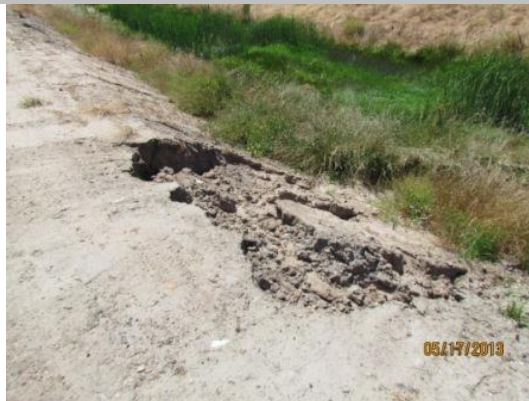
Photo 3 of 3 : pkazi_s_20140415_321.jpg

LM Start	3.48	Rating **	M	Issue No.	24 (cont)
LM End	3.48	Issue Type +	Ma	Location *	WS
Category	Earthen Levee			GPS Latitude/Longitude	
				Start	End
Item	Erosion / Bank Caving			38.131140 °	38.131140 °
				-121.138541 °	-121.138541 °
DWR ID	DWR_NA0017_12_f_2012_24				
Action/Comments					
Schedule repair of erosion site prior to the next inspection.

Updated picture of the erosion on the waterside slope of the levee looking downstream.

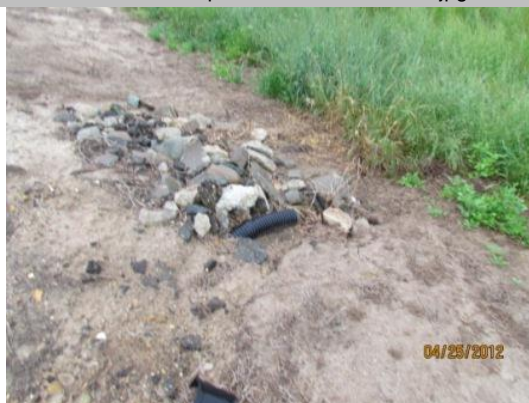
Photo 1 of 1 : pkazi_s_20140415_316.jpg

LM Start	3.51	Rating **	M	Issue No.	17
LM End	3.51	Issue Type +	En	Location *	WS
Category	Earthen Levee			GPS Latitude/Longitude	
				Start	End
Item	Encroachments			38.131490 °	38.131490 °
				-121.138476 °	-121.138476 °
DWR ID	DWR_NA0017_12_s_2012_17				
Action/Comments					
Pipe

An active running pipe was found on the waterside of the levee looking downstream.

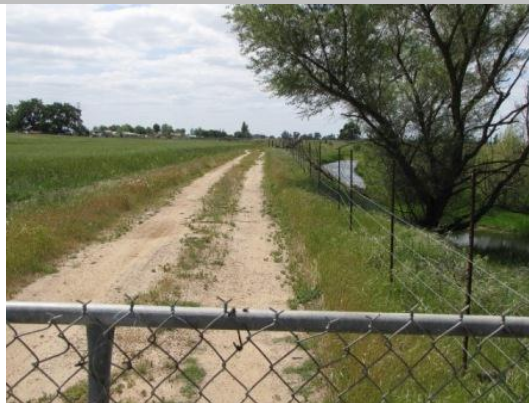
Photo 1 of 1 : pkazi_s_20140415_314.jpg

LM Start	3.53	Rating **	U	Issue No.	10
LM End	3.92	Issue Type +	En	Location *	CR
Category	Earthen Levee			GPS Latitude/Longitude	
				Start	End
Item	Encroachments			38.134740 °	38.134740 °
				-121.133335 °	-121.133335 °
DWR ID	DWR_NA0017_12_s_2012_10				
Action/Comments					
Fence					
Inspector Comments: Farmer has moved fence to water shouder of access road in high ground area of the unit. The fence is blocking access and the gate is locked with farmer's lock. Unable to access, inspect or patrol this portion of the unit.

Fence along waterward sholder and crown of access road. The road cannot be driven through as the fence blocks access. The gate does not have a county key on the gate.

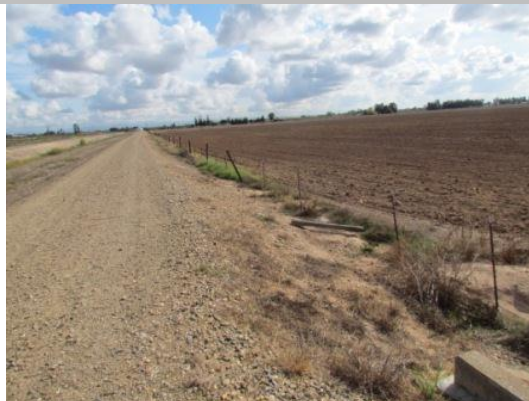
Photo 1 of 2 : pkazi_s_20140415_326.jpg

LM Start	0.00	Rating **	M	Issue No.	3
LM End	1.38	Issue Type +	En	Location *	LS
Category	Earthen Levee			GPS Latitude/Longitude	
				Start	End
Item	Encroachments			38.109328 °	38.110833 °
				-121.159539 °	-121.138757 °
DWR ID	DWR_NA0017_13_s_2012_3				
Action/Comments					
Fence

A fence was located on the landside of the levee looking upstream.

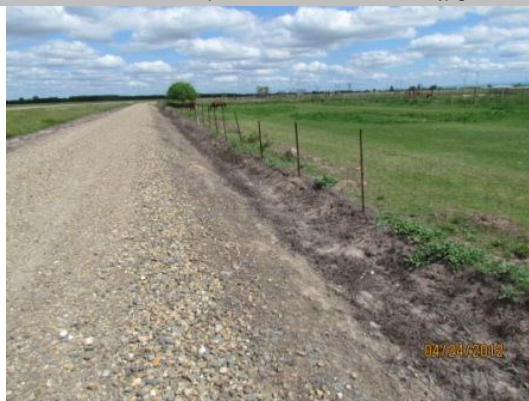
Photo 2 of 2 : pkazi_s_20140415_327.jpg

A fence was found on the landside of the levee looking upstream.

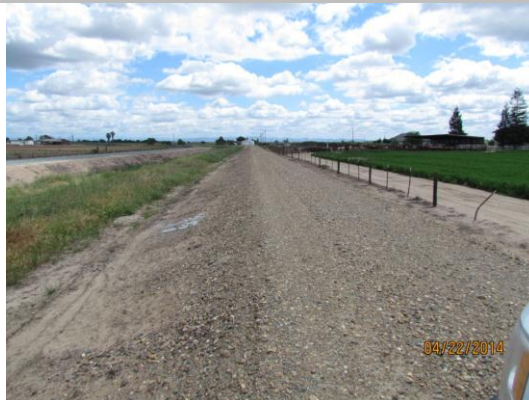
Photo 1 of 1 : pkazi_s_20140428_897.jpg

LM Start	0.26	Rating **	A	Issue No.	1
LM End	0.26	Issue Type +	Ma	Location *	WS
Category	Earthen Levee			GPS Latitude/Longitude	
				Start	End
Item	Vegetation			38.109528 °	38.109528 °
				-121.155848 °	-121.155848 °
DWR ID	DWR_NA0017_13_s_2014_1				
Action/Comments					
Control annual grass and weeds on the levee slopes and easements.

View of the waterside slope of the levee looking upstream.

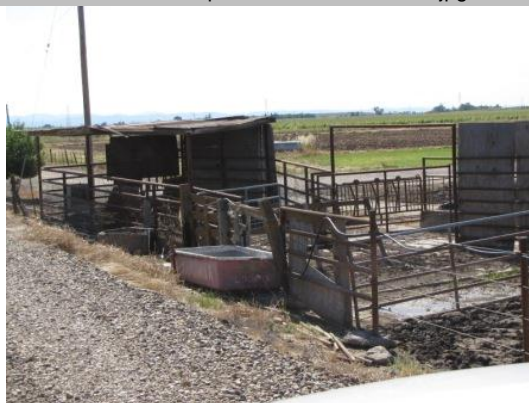
Photo 1 of 1 : pkazi_s_20140415_325.jpg

LM Start	0.39	Rating **	M	Issue No.	2
LM End	0.39	Issue Type +	En	Location *	LS
Category	Earthen Levee			GPS Latitude/Longitude	
				Start	End
Item	Encroachments			38.109580 °	38.109580 °
				-121.153445 °	-121.153445 °
DWR ID	DWR_NA0017_13_s_2012_2				
Action/Comments					
Tank

View of a tub/tank on the landward slope blocking access and visibility looking upstream.

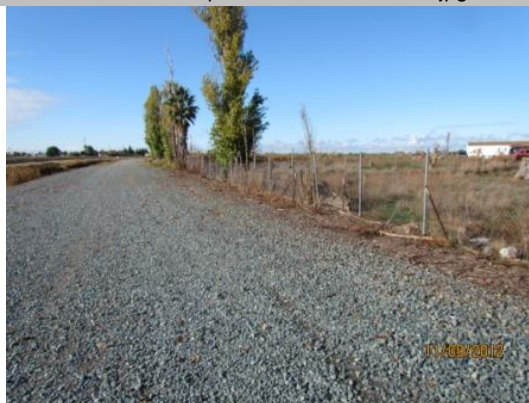
Photo 1 of 1 : pkazi_s_20140415_334.jpg

LM Start	0.02	Rating **	M	Issue No.	6
LM End	0.55	Issue Type +	En	Location *	LS
Category	Earthen Levee			GPS Latitude/Longitude	
				Start	End
Item	Encroachments			38.109670 °	38.111263 °
				-121.159889 °	-121.151091 °
DWR ID	DWR_NA0017_14_s_2012_6				
Action/Comments					
Fence

A fence was found on the landside of the levee looking downstream.

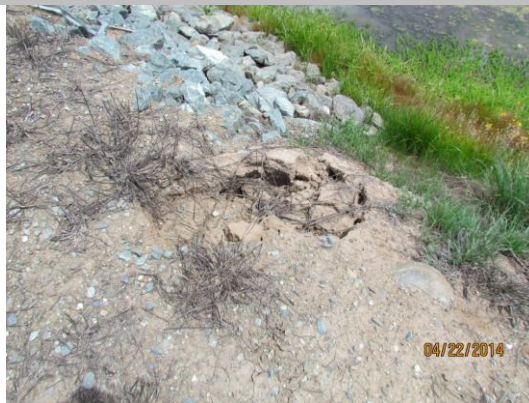
Photo 1 of 2 : pkazi_s_20140428_898.jpg

LM Start	0.43	Rating **	M	Issue No.	8
LM End	0.43	Issue Type +	Ma	Location *	WS
Category	Earthen Levee			GPS Latitude/Longitude	
				Start	End
Item	Animal Control			38.110031 °	38.110031 °
				-121.152630 °	-121.152630 °
DWR ID	DWR_NA0017_14_f_2013_8				
Action/Comments					
No rodents visible, but rodent burrows visible; need to backfill and compact or grout burrows.

Updated picture of the rodent hole on the waterside shoulder of the levee looking upstream during the spring 2014 inspection.

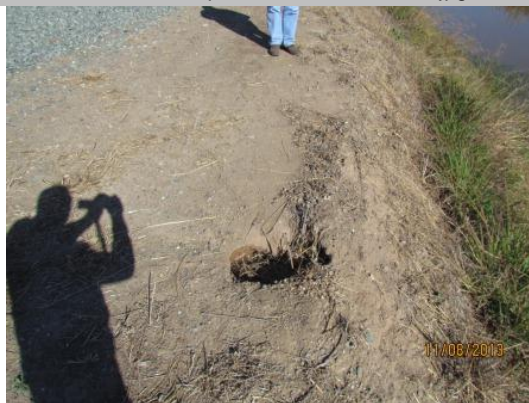
Photo 2 of 2 : pkazi_s_20140415_336.jpg

LM Start	0.43	Rating **	M	Issue No.	8 (cont)
LM End	0.43	Issue Type +	Ma	Location *	WS

View of a rodent hole on the waterside shoulder of the levee looking upstream.

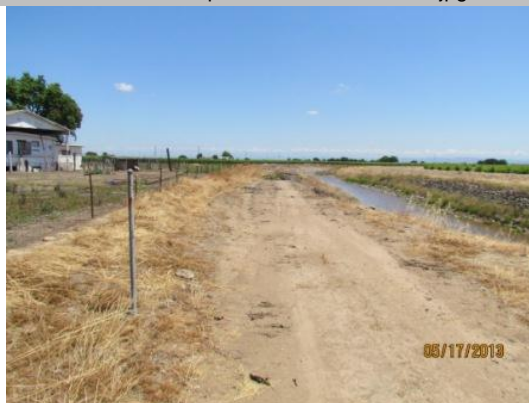
Photo 1 of 1 : pkazi_s_20140415_335.jpg

LM Start	0.57	Rating **	M	Issue No.	7
LM End	0.57	Issue Type +	Ma	Location *	CR
Category	Earthen Levee			GPS Latitude/Longitude	
				Start	End
Item	Crown Surface / Depressions / Rutting			38.111490 °	38.111490 °
				-121.150762 °	-121.150762 °
DWR ID	DWR_NA0017_14_s_2013_7				
Action/Comments					
Repair depressions or ruts in the crown or slope.

Crown depression was found looking upstream.

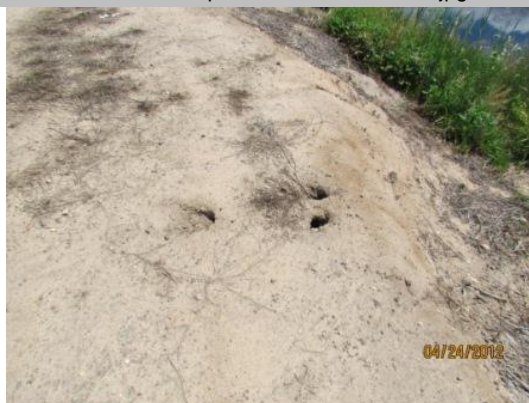
Photo 1 of 1 : pkazi_s_20140415_333.jpg

LM Start	0.61	Rating **	M	Issue No.	5
LM End	0.61	Issue Type +	Ma	Location *	WS
Category	Earthen Levee			GPS Latitude/Longitude	
				Start	End
Item	Animal Control			38.111770 °	38.111770 °
				-121.150112 °	-121.150112 °
DWR ID	DWR_NA0017_14_s_2012_5				
Action/Comments					
No rodents visible, but rodent burrows visible; need to backfill and compact or grout burrows.

Animal holes were found on the waterside of the levee looking upstream.

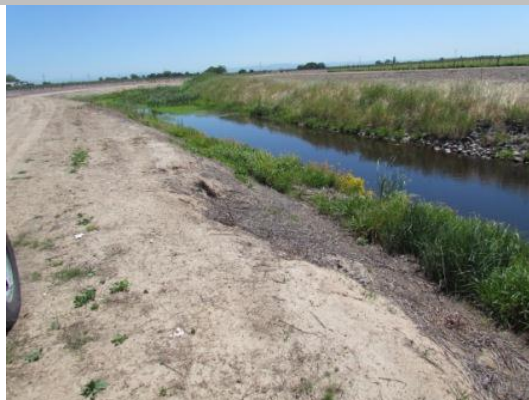
Photo 1 of 2 : pkazi_s_20140415_331.jpg

LM Start	0.61	Rating **	M	Issue No.	4
LM End	0.61	Issue Type +	Ma	Location *	WS
Category	Earthen Levee			GPS Latitude/Longitude	
				Start	End
Item	Erosion / Bank Caving			38.111774 °	38.111774 °
				-121.150073 °	-121.150073 °
DWR ID	DWR_NA0017_14_s_2012_4				
Action/Comments					
Note and monitor erosion site.

Erosion was found on the waterside of the levee.

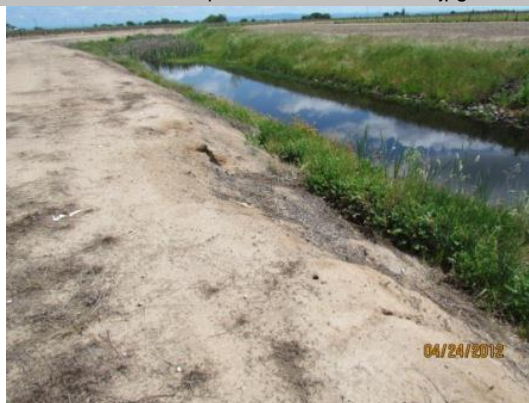
Photo 2 of 2 : pkazi_s_20140415_332.jpg

LM Start	0.61	Rating **	M	Issue No.	4 (cont)
LM End	0.61	Issue Type +	Ma	Location *	WS
Category	Earthen Levee			GPS Latitude/Longitude	
				Start	End
Item	Erosion / Bank Caving			38.111774 °	38.111774 °
				-121.150073 °	-121.150073 °
DWR ID	DWR_NA0017_14_s_2012_4				
Action/Comments					
Note and monitor erosion site.

Erosion was found on the waterside of the levee looking upstream. This picture was taken during spring 2012 inspection.

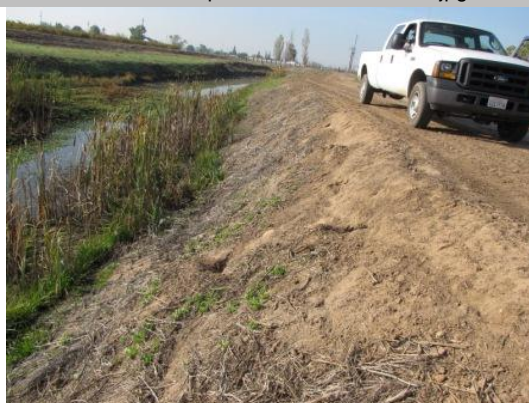
Photo 1 of 1 : pkazi_s_20140415_328.jpg

LM Start	0.65	Rating **	M	Issue No.	1
LM End	0.65	Issue Type +	Ma	Location *	WS
Category	Earthen Levee			GPS Latitude/Longitude	
				Start	End
Item	Animal Control			38.112050 °	38.112050 °
				-121.149524 °	-121.149524 °
DWR ID	DWR_NA0017_14_s_2012_1				
Action/Comments					
Exterminate rodents and backfill and compact or grout burrows.

View of rodent holes in the waterward berm looking downstream.

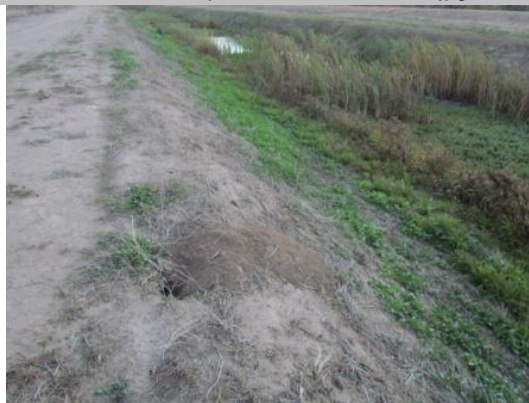
Photo 1 of 1 : pkazi_s_20140415_330.jpg

LM Start	0.73	Rating **	M	Issue No.	3
LM End	0.73	Issue Type +	Ma	Location *	WS
Category	Earthen Levee			GPS Latitude/Longitude	
				Start	End
Item	Animal Control			38.111851 °	38.111851 °
				-121.148358 °	-121.148358 °
DWR ID	DWR_NA0017_14_s_2012_3				
Action/Comments					
No rodents visible, but rodent burrows visible; need to backfill and compact or grout burrows.

A rodent hole was found on the waterside shoulder of the levee looking upstream.

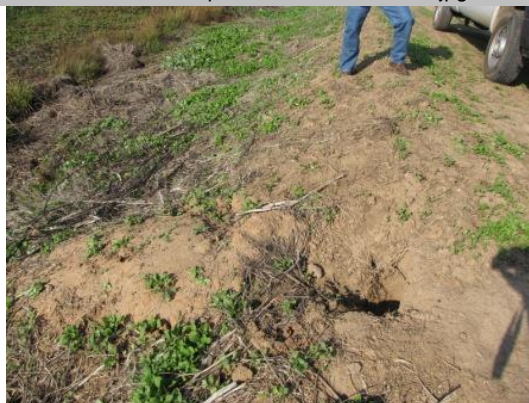
Photo 1 of 1 : pkazi_s_20140415_329.jpg

LM Start	0.83	Rating **	M	Issue No.	2
LM End	0.83	Issue Type +	Ma	Location *	WS
Category	Earthen Levee			GPS Latitude/Longitude	
				Start	End
Item	Animal Control			38.110628 °	38.110628 °
				-121.147429 °	-121.147429 °
DWR ID	DWR_NA0017_14_s_2012_2				
Action/Comments					
Exterminate rodents and backfill and compact or grout burrows.

View of a large diameter rodent hole in the waterward berm looking downstream.

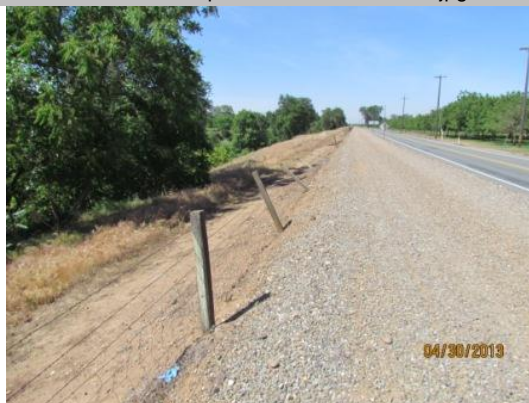
Photo 1 of 1 : pkazi_s_20140415_337.jpg

LM Start	0.37	Rating **	M	Issue No.	1
LM End	0.64	Issue Type +	En	Location *	WS
Category	Earthen Levee			GPS Latitude/Longitude	
				Start	End
Item	Encroachments			38.049552 °	38.047016 °
				-121.014926 °	-121.020586 °
DWR ID	DWR_NA0017_15_s_2012_1				
Action/Comments					
Fence

Fences were found on the waterside shoulder of the levee looking downstream.

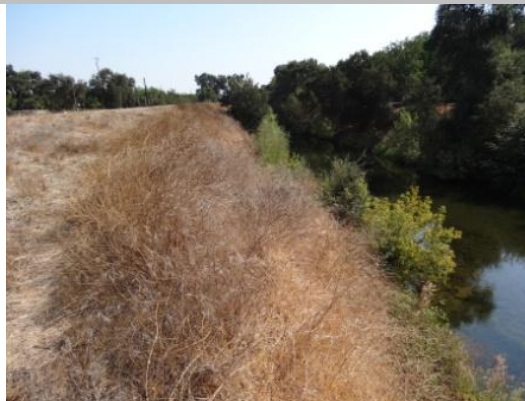
Photo 1 of 1 : pkazi_s_20140415_342.jpg

LM Start	0.41	Rating **	M	Issue No.	7
LM End	1.32	Issue Type +	Ma	Location *	WS
Category	Supplemental			GPS Latitude/Longitude	
				Start	End
Item	DWR Erosion Survey			38.045818 °	38.045818 °
				-121.023955 °	-121.023955 °
DWR ID	DWR_NA0017_15_s_2014_7				
Action/Comments					
Inspector Comments: 9/12/2013: No significant changes observed. 08/22/2012: Site has been revisited. No significant changes observed. 09/02/2011: No significant changes observed on site. 11/02/2010: No significant changes observed. The mile-long erosion continues to degrade the bank. There are a few trees along the mile-long stretch on the lower bank slope that are affected by the scarp. WS Levee Slope was changed to 2:1. As a result, normalized score increased from 62 to 65. 08/05/2010: Recommended for waterside repair, per CLRO; "water velocity is a major factor for accelerating bank slope erosion." 8/12/2009: Near-vertical bank erosion; degrading channel is incising the banks; recommend annual assessment and monitoring of critical erosion site, per CLRO CES Evaluation 2008 Report; district is monitoring site for changes in condition; site was previously rated "U". 2007: Visited site 02/06/2007; possible critical site. [2013 Site ID:NA0017U15RM22.91]

Looking upstream.
